PROJECT MEMORANDUM

Subject: Options for Improving Disk Filter Reliability
Prepared For: Mary Bannister, PVWMA
Kevin Silviera, City of Watsonville
Prepared By: Paul Friedlander
Reviewed By: Keith Bourgeois
Date: April 8, 2016
Project Number: 8347G.00

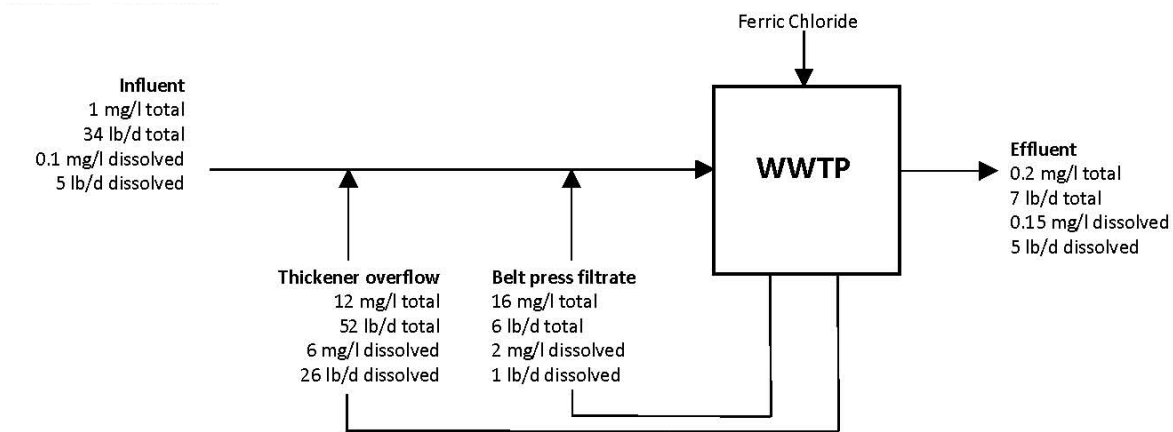
A partial iron balance for the wastewater treatment plant based on sampling done by City staff in July 2015 is shown in Figure 3. Potential sources of iron in the filter feed include iron present in potable water, iron added in the generation of domestic and industrial wastewater, and iron added in the wastewater treatment process. City of Watsonville potable water averages 0.03 mg/l of iron.¹ Total iron is measured in the plant influent once per year, and averages around 1 mg/l. Therefore it can be concluded that the iron contribution from City of Watsonville potable water is negligible. Iron is added in the wastewater treatment process through ferric chloride addition in the gravity thickener and belt press sludge dewatering.

Figure 3: Average wastewater treatment plant iron data July 2015

It is possible that reductions in iron concentrations in the wastewater influent through source control, or reductions in the amount of iron added in the wastewater treatment process through use of alternative coagulants could reduce iron scaling on the disk filters. Improvements to the filter cleaning system or addition of a third filter train, however, should provide a more dependable solution, and are outlined in the following sections.

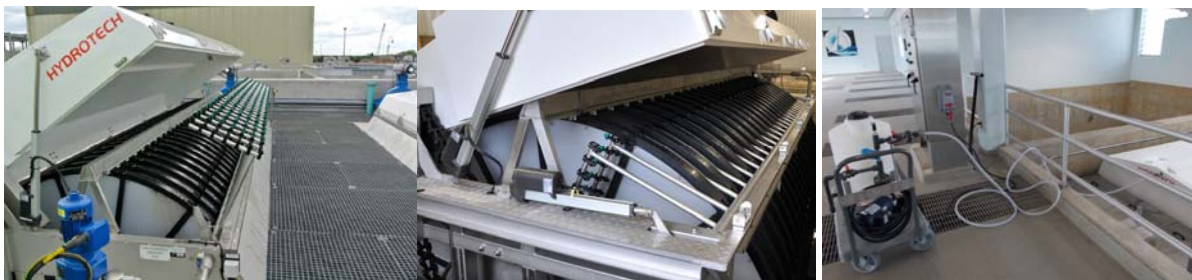
Since the Recycled Water Treatment Facility was constructed and the Hydrotech disk filters were installed, Kruger has developed an automated cleaning system (ACS) for the Hydrotech disk filter to address problems with filter clogging and scaling. Photos of an ACS system are shown in Figure 4. The ACS consists of a chemical spray header with spray nozzles on both sides of each filter disk, and piping or a hose connecting the spray nozzles to a pump and storage tank with cleaning chemical. Control logic is incorporated into the system controls to sequence the spraying of cleaning chemical on to the filter disks so there is sufficient chemical contact time on the disk surface.

Figure 4: Kruger ACS System (courtesy of Kruger)

Automated cleaning systems could be installed on the existing filter trains to allow chemical cleaning of the filter disks in a matter of minutes rather than hours. Shortening the required application and cleaning time could allow for a more frequent chemical cleaning system in a shorter period of time (requiring less filter down time) which could mitigate filter media fouling and improve reliability.

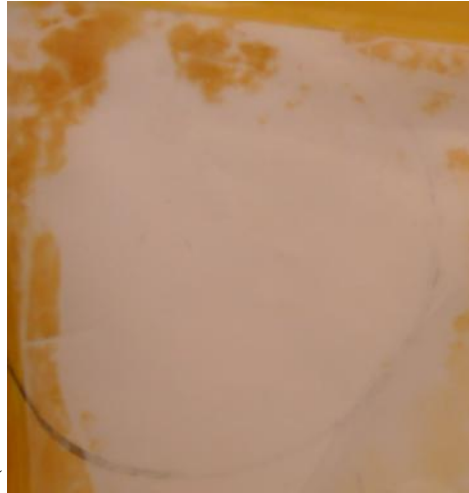
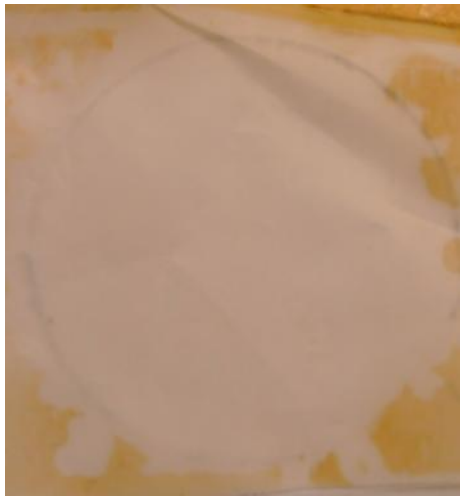
The results were similar with all acid treatments and the clogging tends to be almost removed,

Figure 2). The most likely cause for clogging is the coagulant used in the Densadeg process. It is assumed that the client is using some kind of Iron compound which would explain the coloring and why it is easily removed when treating it with an acid. Using only bleach was not as efficient as the acids. However combining Hydrochloric acid and thereafter bleach seemed to improve the capacity with another 5 % compared to only using an acid.

The filtration capacity after the tested treatments was only 75-80 % of the filtration rate expected for a new sample of the same type of filter cloth. However the sample from Watsonville looked completely clean after being treated with Hydrex 4921 or HCl, an explanation to this could be that there was a difference between different batches of filter media sent from the manufacturer.

Figure 2: Pictures of the filter media before and after treatment with Hydrex 4921 (10%) and HCl (15%).

- The fouling of the filter is most likely due to Iron
- Hydrex 4921 with a 10 % (weight) solution can be recommended to use to recover the filtration capacity since it will remove the fouling
- The recovered capacity of the sample was lower than the expected capacity of a new sample of the 10 micron media that was used in 2008.
- Replacement of old panels to Hydrotech's current 10 micron media will most likely increase the capacity of the filters with at least 10-20 %.
